Subject: Site Stabilization and Post-Planting, Bledsoe County Correctional Complex Stream & Wetland Mitigation (TDEC NRS 09.009, USACE 2005-02425).

Enclosures: Planting and Coir Log Installation Photos

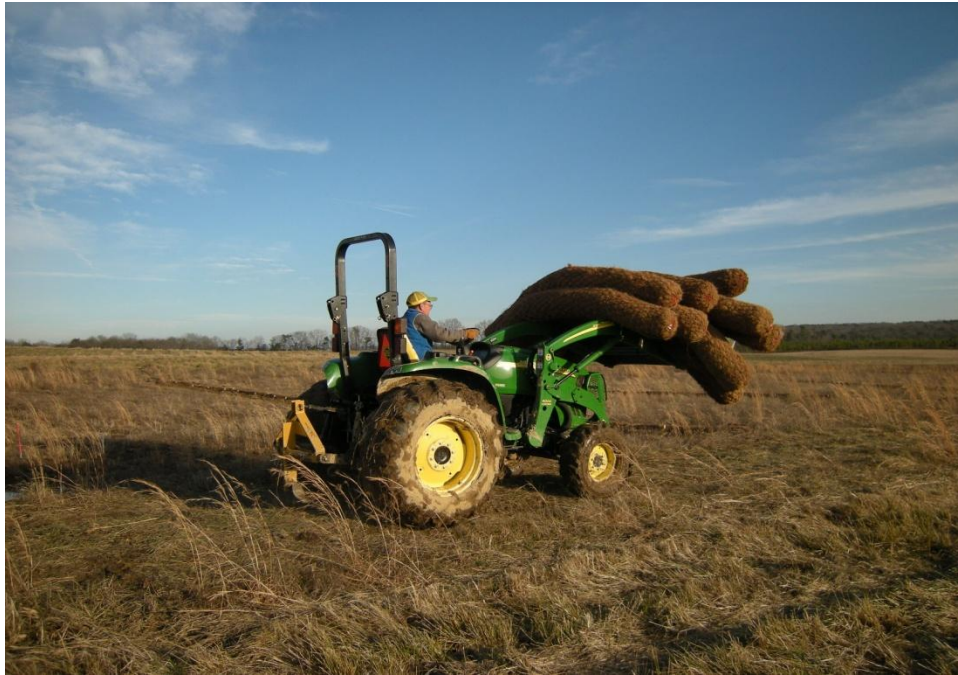
Photo 1. Because the original grading of the wetland creation area in 2010 was conducted late in the year, soil binding vegetation was never established. Subsequent rainfall caused significant erosion and loss of soil in some places. In effort to prevent continued site degradation, 2,550 ft of coir erosion logs were installed.

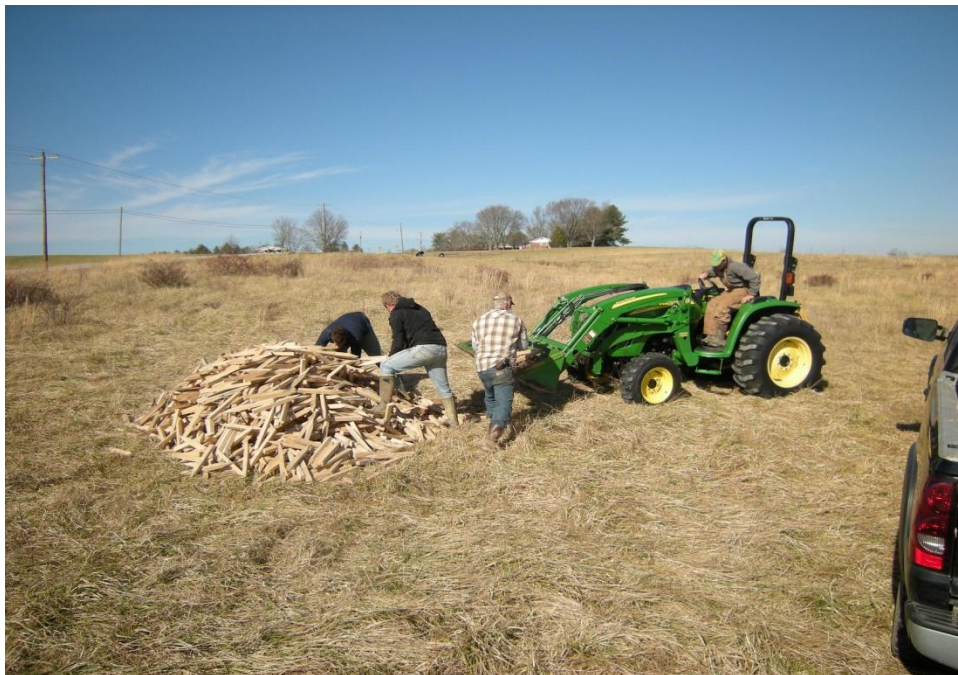
Photo 2. A total of 23 coir log “dams” were established on the 4.91 acre wetland creation site. All were secured by staking them in place.

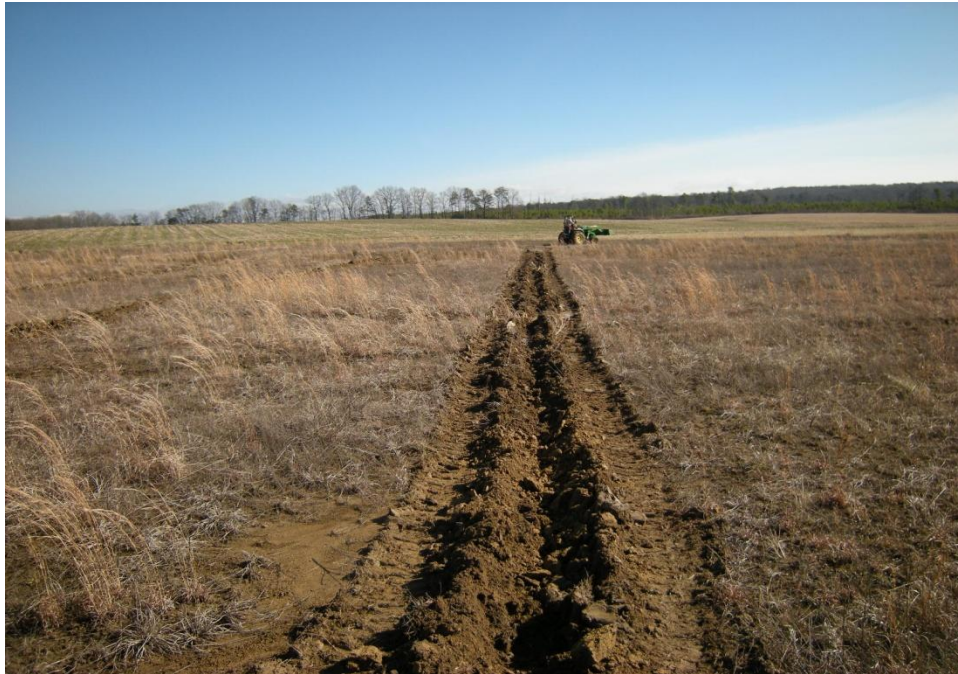
Photo 3. To lessen the likelihood of water undercutting the dams, the coir logs were placed into shallow trenches. These were cut with a single blade plow.

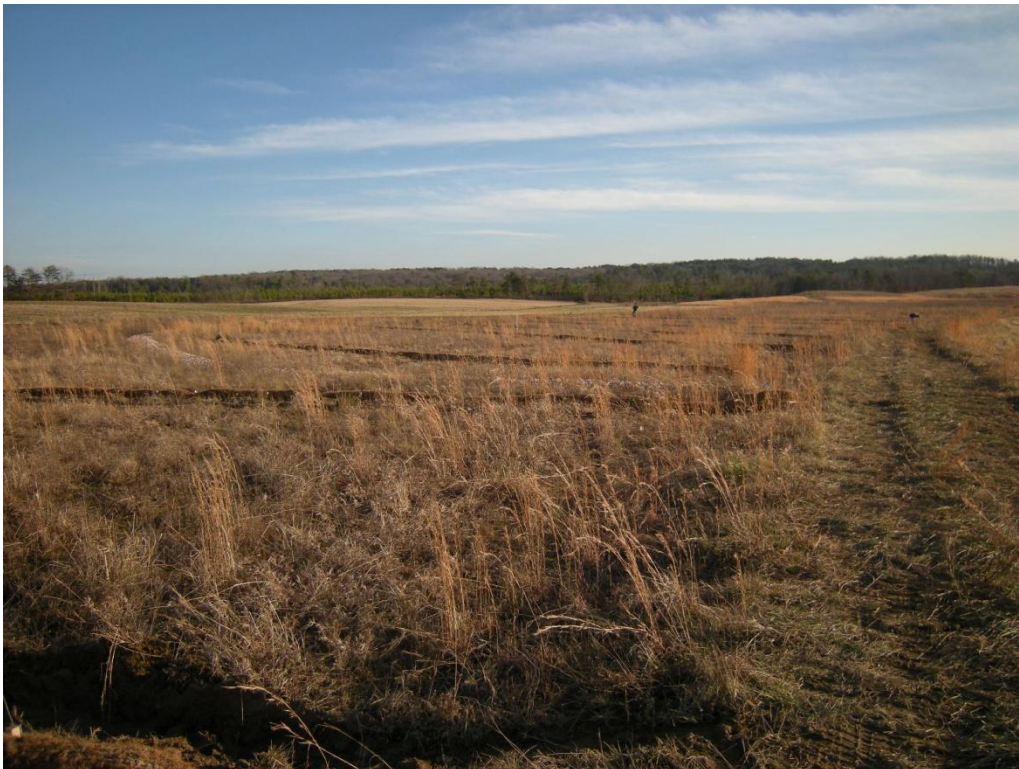
Photo 4. The dams were spaced at approximately 40 ft intervals and were placed roughly perpendicular to the direction of water flow. Close inspection of the photo reveals several of these dams. This view is looking southward.

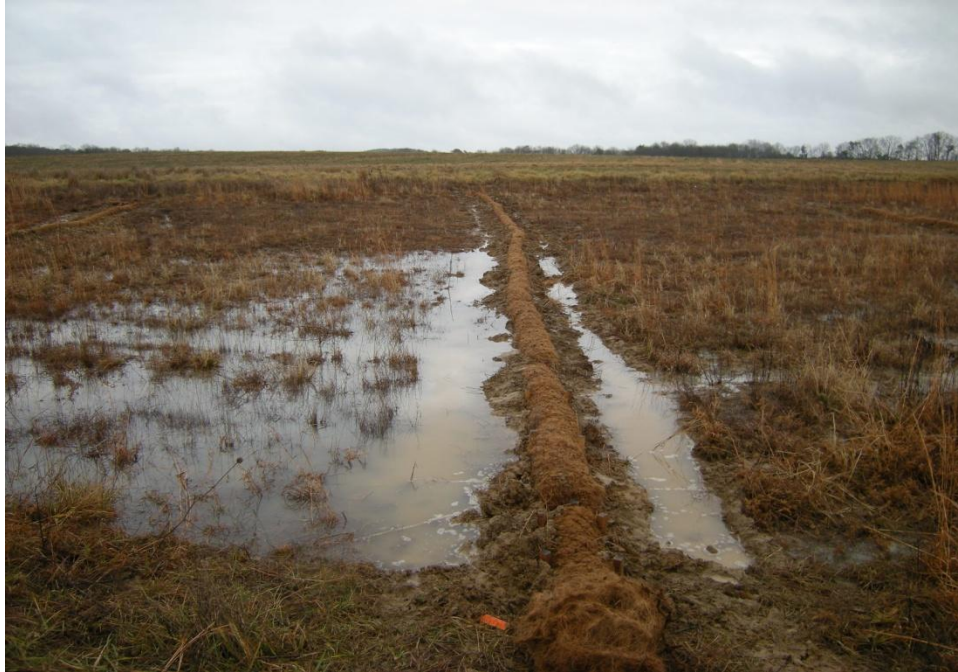
Photo 5. One day after the coir logs were installed the site received approximately 0.5 inches of rainfall. As can be seen, the dams were effective in ponding water. Equally important is that they will also help the accretion of sediments that will provide a better growth medium for wetland vegetation, both planted and invasive.

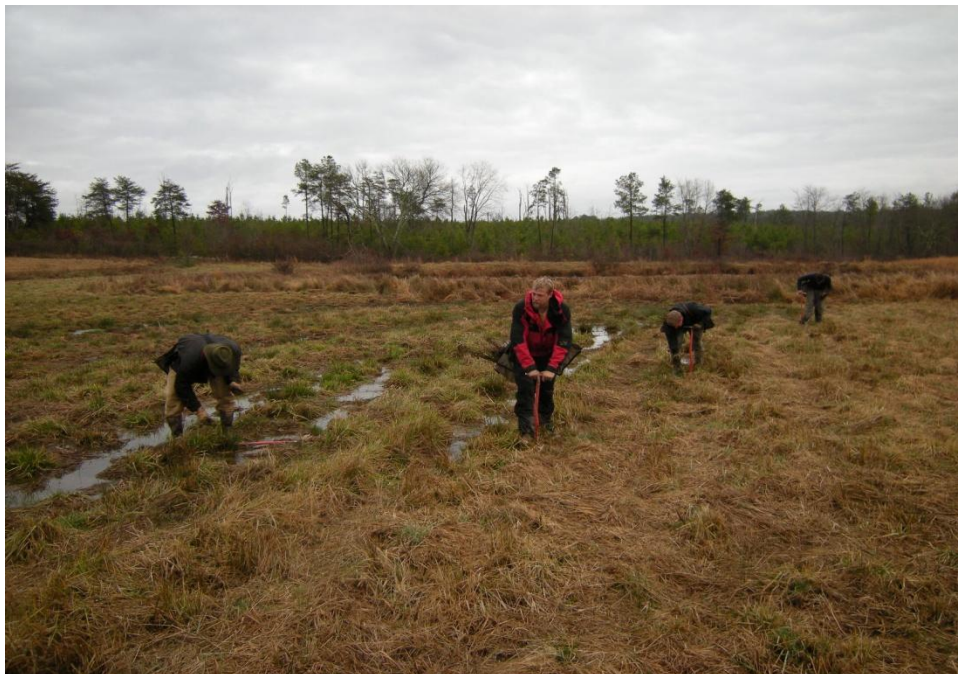
Photo 6. The revised mitigation plan also provided for the replanting of wetland enhancement areas. These areas had been mown several weeks earlier to facilitate planting.
